| <b>OLR-86-2-EPTU-MEM-0001</b> | <b>Memorandum</b> | <b>OLRT Project</b> | |

**Document No.**           **OLR-86-2-EPTU-MEM-0001**  
**Department No:**       **Technical Memo**  
**Date:**                   **21<sup>th</sup> March 2014**  
**From:**                  **Roger Schmidt, Technical Director**  
**To:**                      **David Whyte, Project Director**  
**Subject:**               **Resuming Tunneling at East Portal**

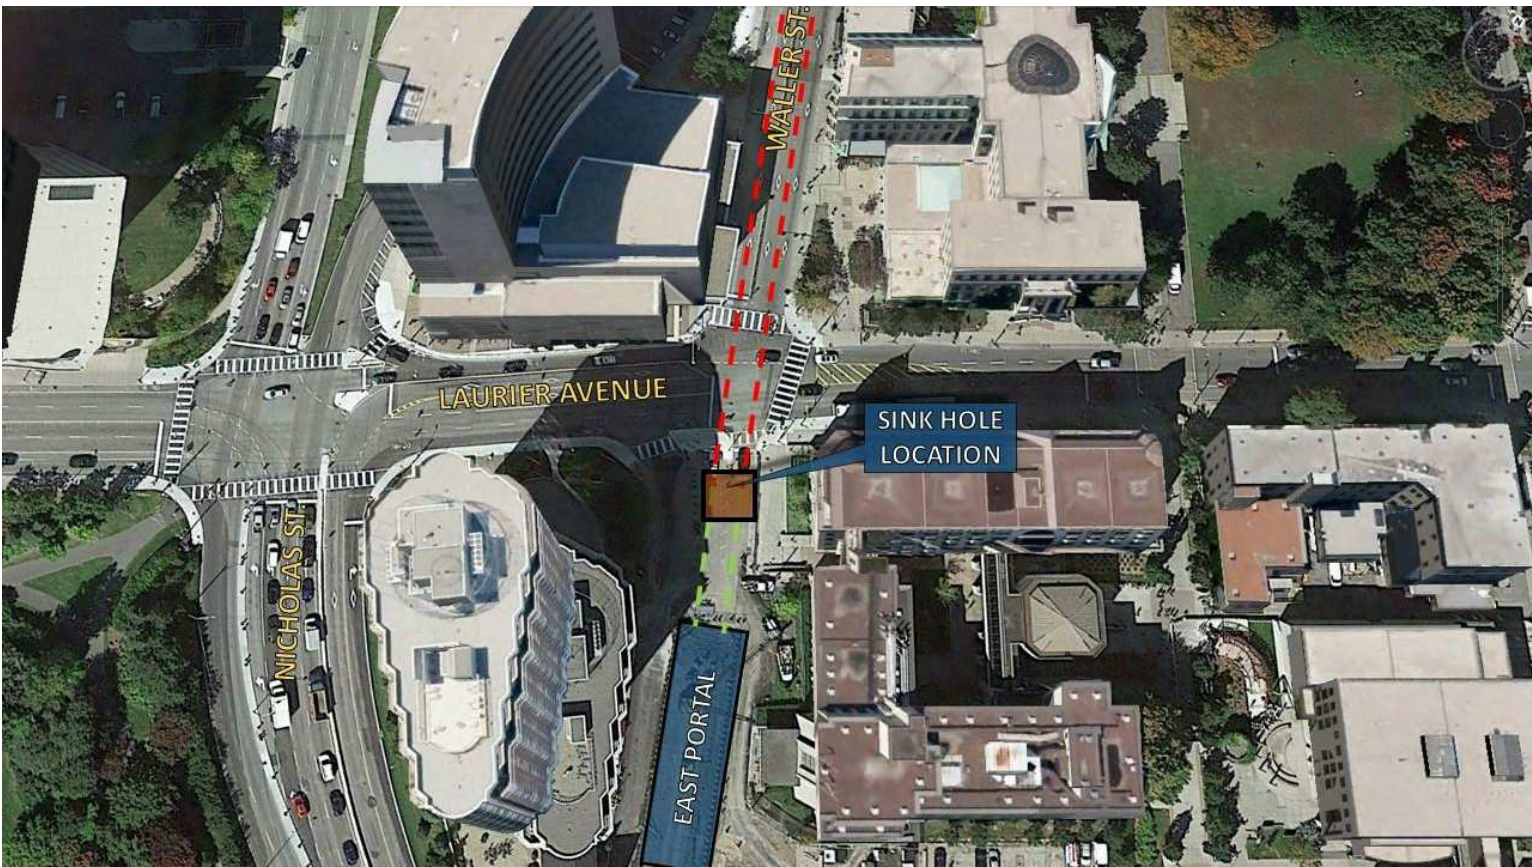
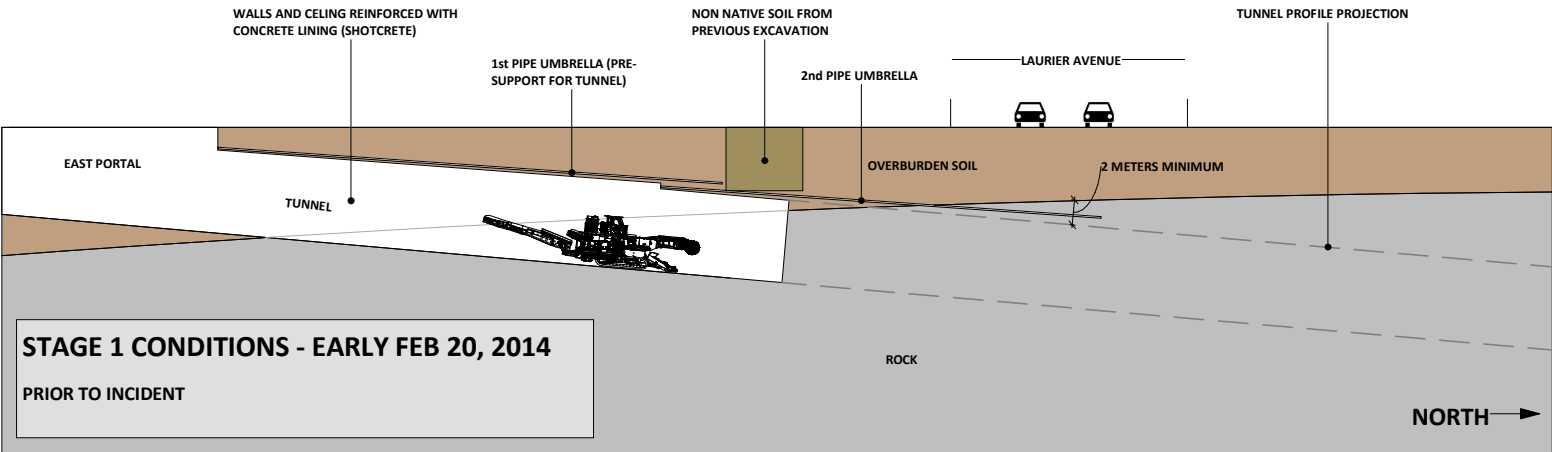
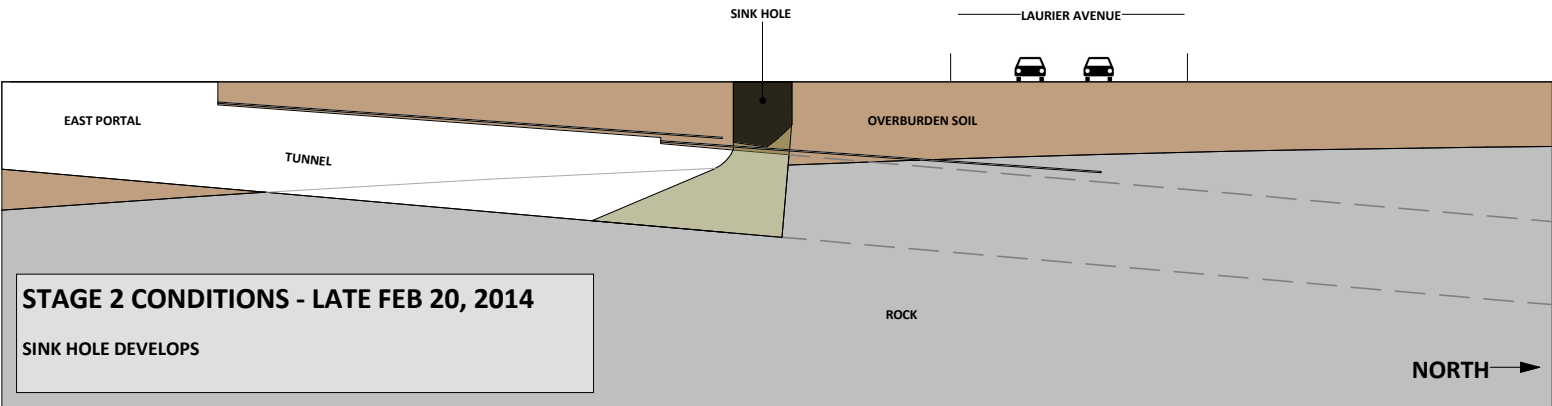
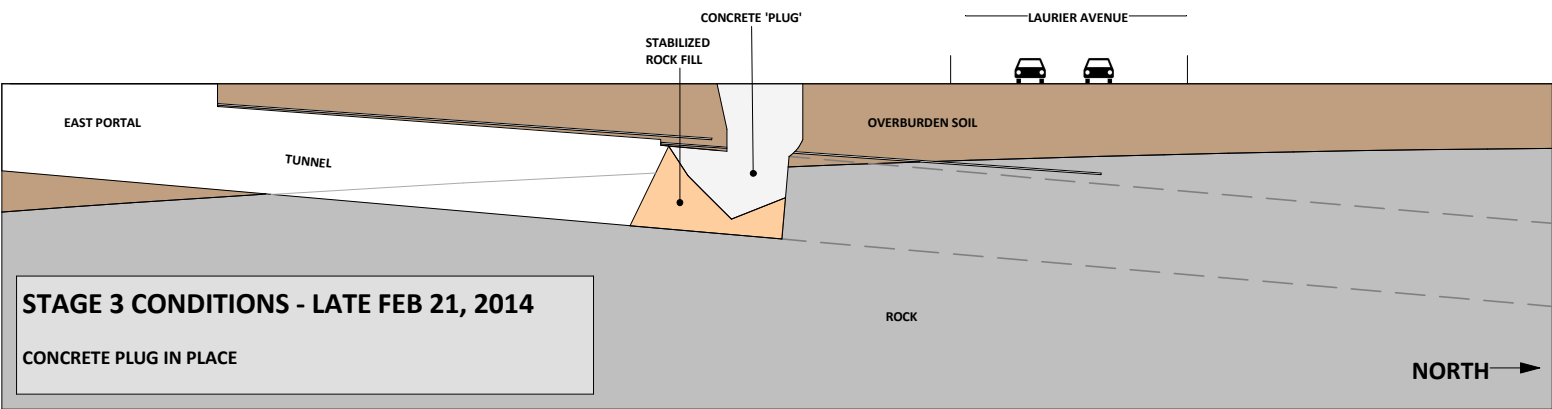
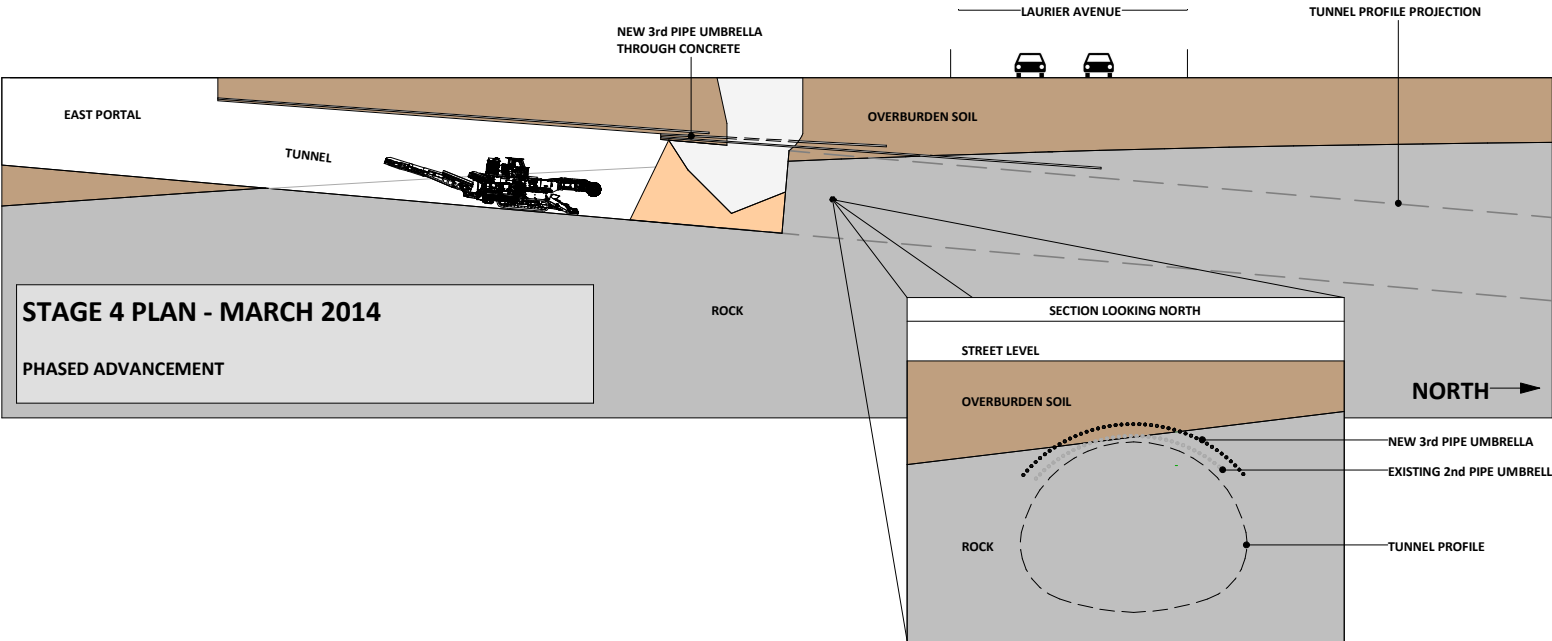
**Roger Schmidt, P.Eng.**  
**Technical Director, OLRT Constructors**  
 Encl. Infographic

For immediate next steps, the tunneling program adjacent to the sinkhole is planned to continue in phases. The first phase will keep the tunnel in known and solid geotechnical conditions while additional confirmatory boreholes are drilled and analysed. It will also involve investigative probe drilling within the tunnel, and grouting to confirm stable tunnel face conditions. The second phase of tunneling works will resume after we analyze new borehole data. The graphic attached shows this in concept.
